Fireplace & Chimney Inspection Report

Sandy Spring Inspections
1001 Ashton Road
Ashton, MD 20861

Report Overview

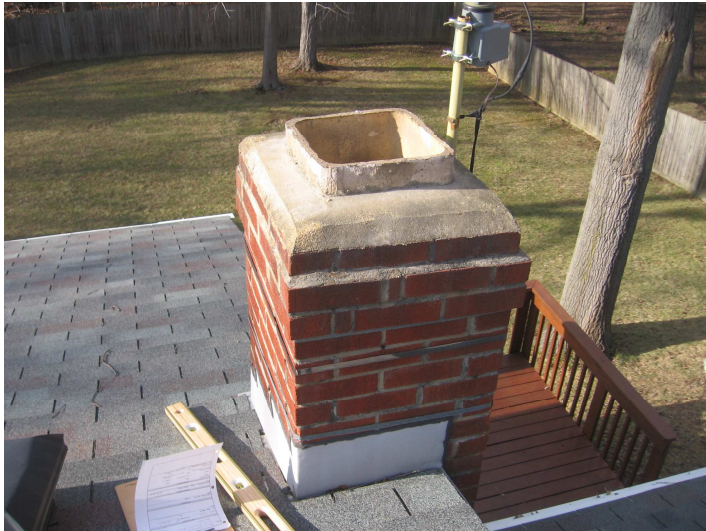
2.0 – The concrete crown for the masonry chimney is good condition. Minor deterioration was noted to the top section of clay tile liner. Improvement should be coordinated with future repairs.

2.1 – A good quality chimney cap (including vermin screen) is installed. Consider replacing the galvanized cap with a stainless steel cap if rust stains are noted.

2.2 – Chimneys should be at least three (3) feet above the roof (which it is) and at least two (2) feet above anything that is within ten feet. This chimney is 3 feet above the roof but is only 18” above obstructions within 10 feet. Improvement should be coordinated with future repairs.

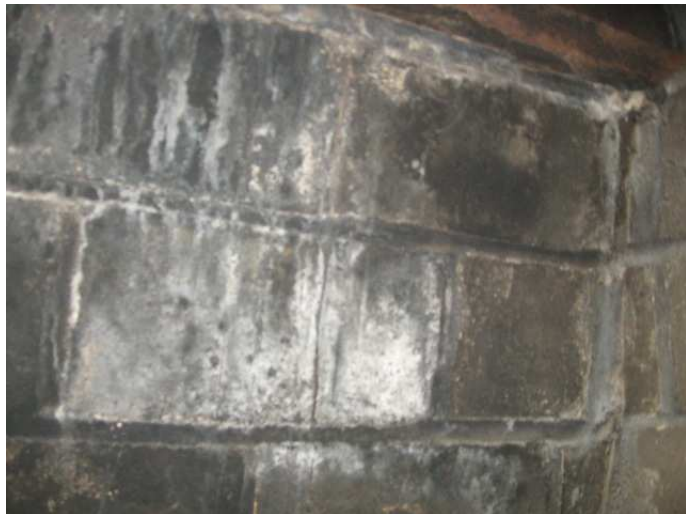
3.0 – The rear wall of the masonry firebox shows evidence of moisture infiltration (slight efflorescence). The mortar is sound. The flashings, crown and cap are in good condition. The firebox should be monitored for evidence of further moisture infiltration.

3.1 – The fireplace has been properly designed and constructed. The smoke chamber is of non-standard design, the top of the smoke chamber is flat. Normally, smoke chambers have tops that are sloped (to direct smoke) toward the flue. My concern is that this configuration will impact the ability of this fireplace to “draw” properly.

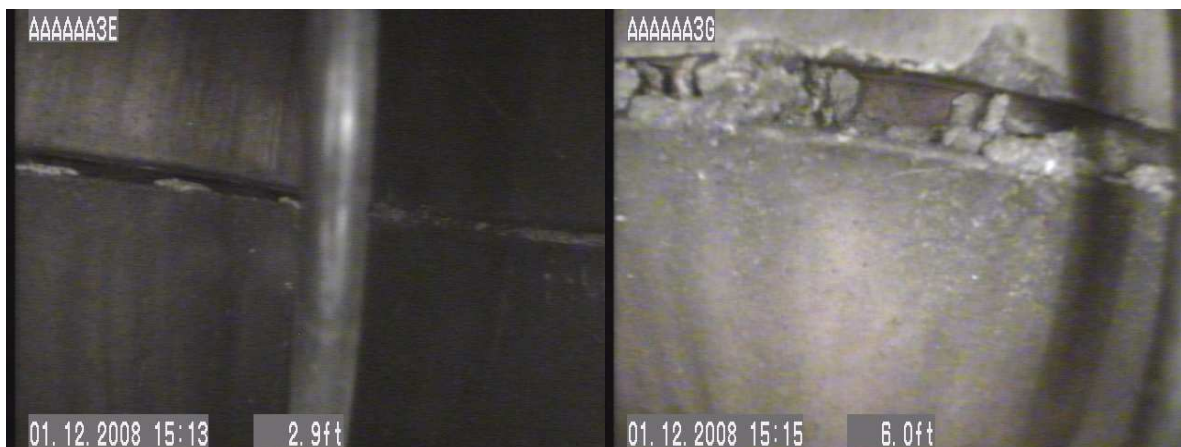
5.0 – The scan of the fireplace revealed several gaps between sections of clay tile flue liner. Improvement will involve installation of a flexible metal liner system. The liner should be appropriately insulated.

Based on the finding of this visual investigation, the video chimney scan, and the opinion of this inspector, *this fireplace is unsafe for operation*. Improvement will involve installation of a flexible metal liner system. The liner should be appropriately insulated.
